DEPARTMENT OF TRANSPORTATION**DIVISION OF ENGINEERING SERVICES**

Contract #: 04-0120F4Cty: SF/ALA Rte: 80 PM: 13.2/13.9File #: 69.28**WELDING INSPECTION REPORT****Resident Engineer:**Pursell, Gary**Address:** 333 Burma Road**City:** Oakland, CA 94607**Report No:** WIR-011739**Date Inspected:** 12-Jan-2010**Project Name:** SAS Superstructure**OSM Arrival Time:** 1900**Prime Contractor:** American Bridge/Fluor Enterprises, a JV**OSM Departure Time:** 700**Contractor:** Zhenhua Port Machinery Company, Ltd (ZPMC), Changxing Island **Location:** Shanghai, China**CWI Name:** See Below**CWI Present:** Yes No**Inspected CWI report:** Yes No N/A**Rod Oven in Use:** Yes No N/A**Electrode to specification:** Yes No N/A**Weld Procedures Followed:** Yes No N/A**Qualified Welders:** Yes No N/A**Verified Joint Fit-up:** Yes No N/A**Approved Drawings:** Yes No N/A**Approved WPS:** Yes No N/A**Delayed / Cancelled:** Yes No N/A**Bridge No:** 34-0006**Component:** OBG and Tower**Summary of Items Observed:**

OBG BAY 5

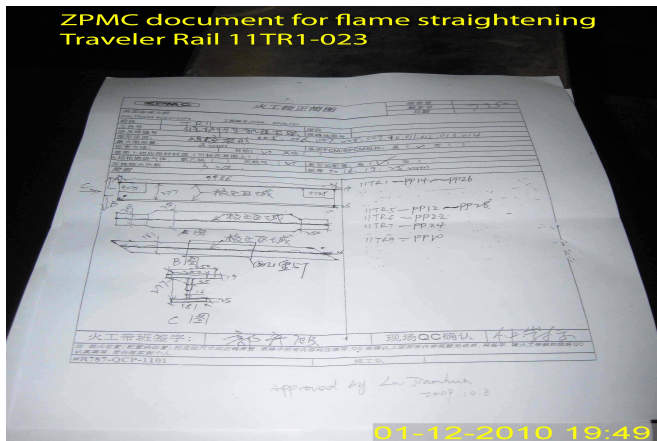
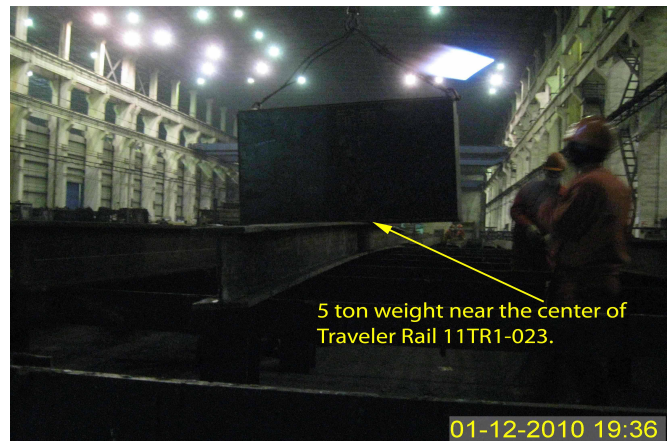
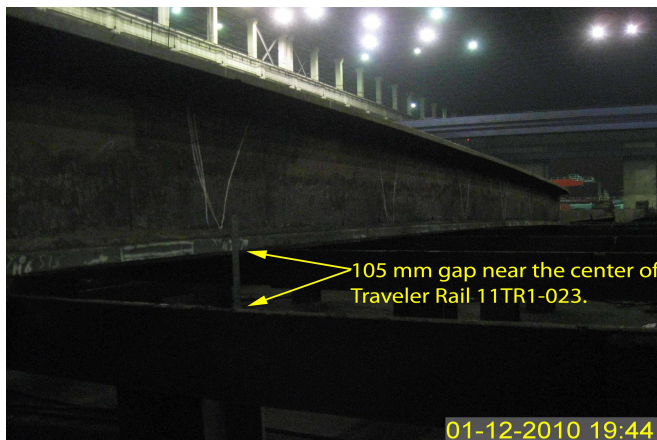
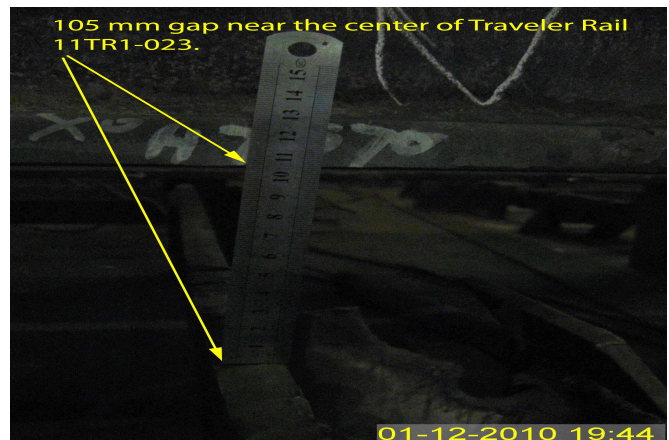
At around 1930 hours this QA Inspector observed ZPMC workers were performing heat straightening of Traveler Rail 11TR1-032 and ZPMC personnel have placed a five ton weight on this Traveler Rail as the heat is being applied. This QA Inspector did not observe any ZPMC QC personnel in OBG Bay 5 as this heat straightening was taking place. A review of ZPMC heat straightening record reveals this document is written using only the Chinese language and there is no Caltrans Engineering stamp on this document. This QA Inspector observed Traveler Rail 11TR1-032 is sitting on a raised work platform and is supported near each end of the Traveler Rail. The Traveler Rail has a bow of approximately 105 mm as measured near the center of the Traveler Rail. Note: this measurement was taken after ZPMC applied an unknown amount of heat with a 5 ton weight bearing down on top of Traveler Rail 11TR1-032. ZPMC CWI Mr. Liu Fe Wen informed this QA Inspector that he has a HSR document that allows a weight to be applied. This QA Inspector informed ZPMC CWI Mr. Liu Fe Wen that no Caltrans Engineer has approved this heat straightening document and an incident report is going to be issued to document this violation. See the photographs below for additional information
